THE HAZARDS OF DEFECTS AND POOR QUALITY OF ALUMINUM MATERIALS

FORMÁNEK Josef, KUČEROVÁ Ludmila, TOCHYLIN Mykhailo

University of West Bohemia in Pilsen, Pilsen, Czech Republic, EU, skal@kmm.zcu.cz

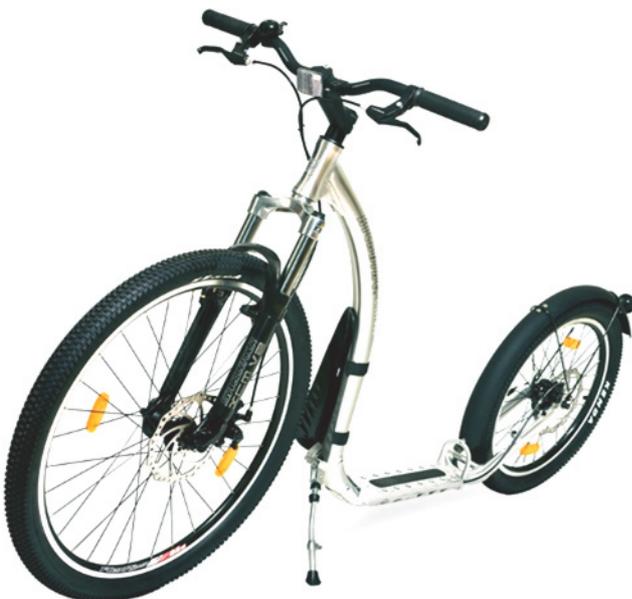
Al-Si alloy were used to produce the front forks for a downhill sports scooter (see Fig. 1).

Fig. 1 The front fork of a downhill sports scooter

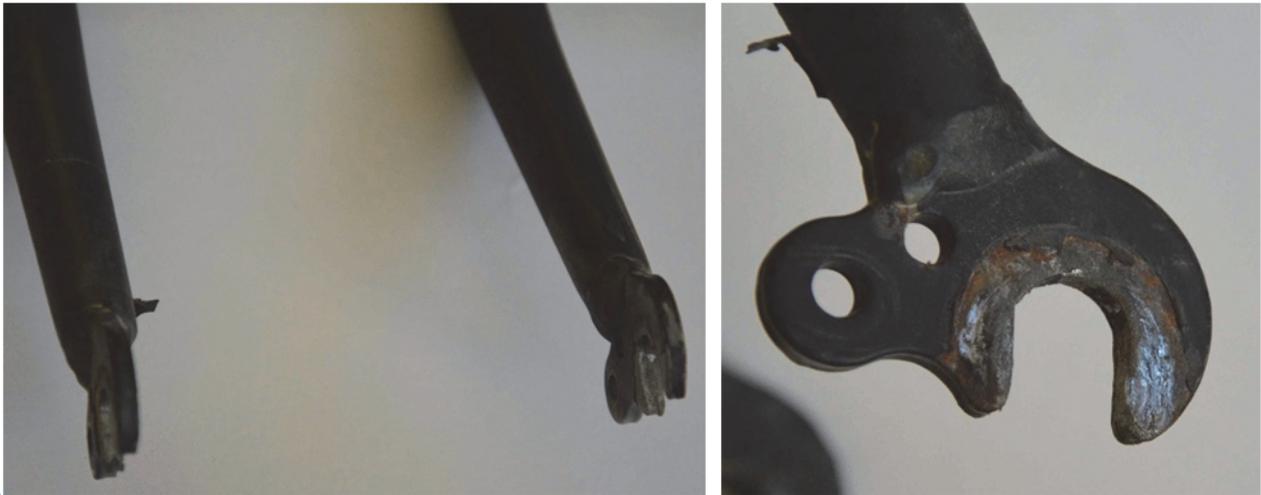
The loaded front wheel fork withstood test modes with only slight damage - enlargement of wheel mounts (see **Fig. 2**). The basic software simulation verified that the supporting profile was sufficiently structurally designed, and that is why no additional material analysis was carried out.

Fig. 2 The steel front wheel mounts and detail of magnification opening handle

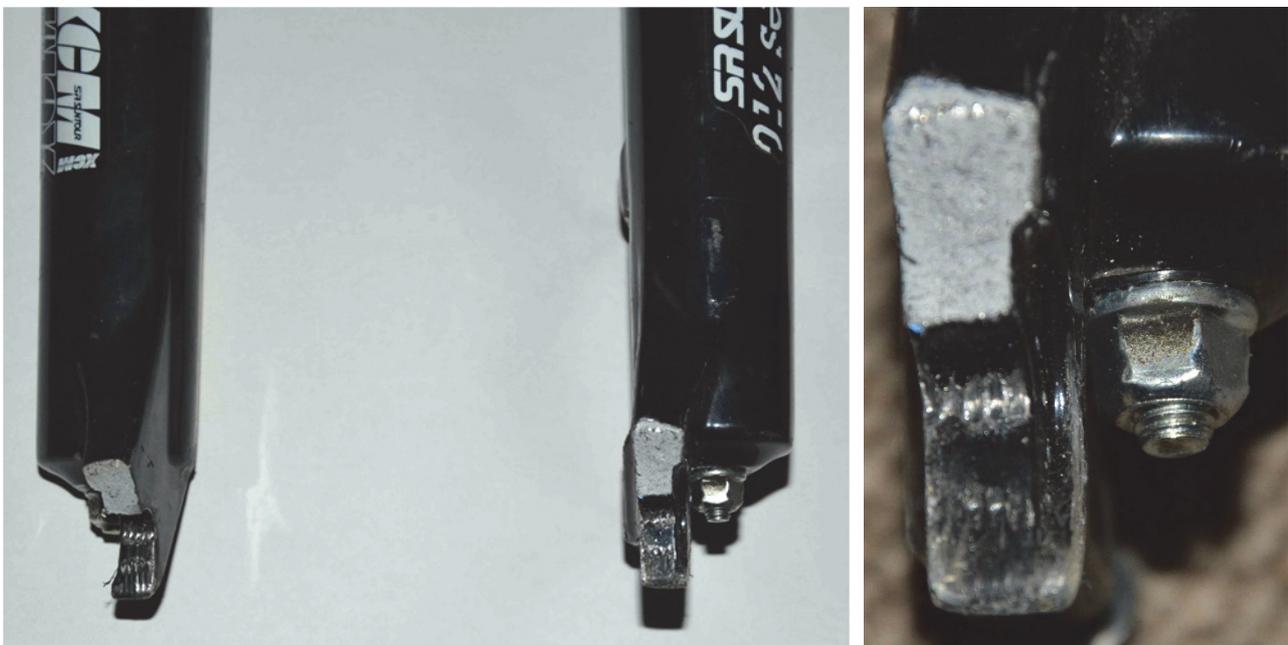
Fig. 3 The damage to the front wheel mounts and detail of damage

The front forks have a lifetime warranty, and subsequent control simulation using FEM verified that the front forks have a real long-term durability of several tens of years [5-6]. The reality was however different, this part broke after about 700 km, the damage being at the front wheel mounts. Small initialization cracks were found upon closer examination (see **Fig. 3**). According to the basic simulation in the SW, it was verified that the carrier profile was sufficiently structurally designed to bear the load and therefore we proceeded to carry out material and fracture analysis [7-8]. Metallographic sections were created and examined in detail with surprising results.

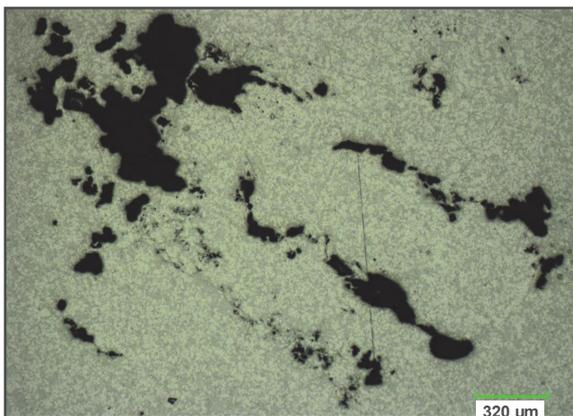
A metallographic sample was prepared from an area about 1cm below the fracture surface. Many pores and shrinkages of various sizes were observed at the polished surface of the sample, proving the poor quality of the material. These defects were so large that they were also visible by the naked eye, some of them reaching sizes in the range of mm (**Fig. 4**).

Fig. 4 Large shrinkage in material

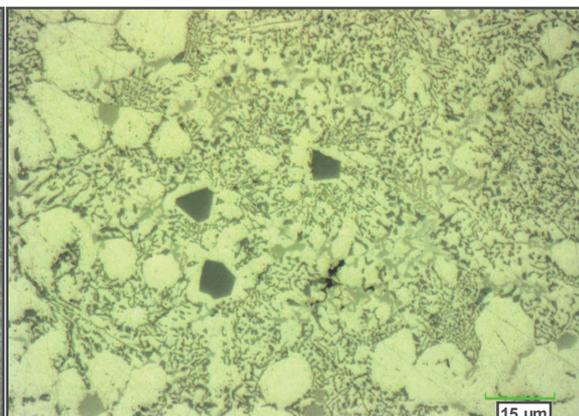
Fig. 5 Dendritic microstructure with eutectic network and several kinds of particles

The sample was further etched using Keller reagent to reveal the microstructure. The microstructure was dendritic and rather complex, consisting of solid solution matrix with Al-Si eutectic among them (**Figs. 5 - 7**). A relatively large fraction of the microstructure, about 50 %, consisted of primary aluminum α -Al dendrites distributed relatively evenly in a eutectic matrix.

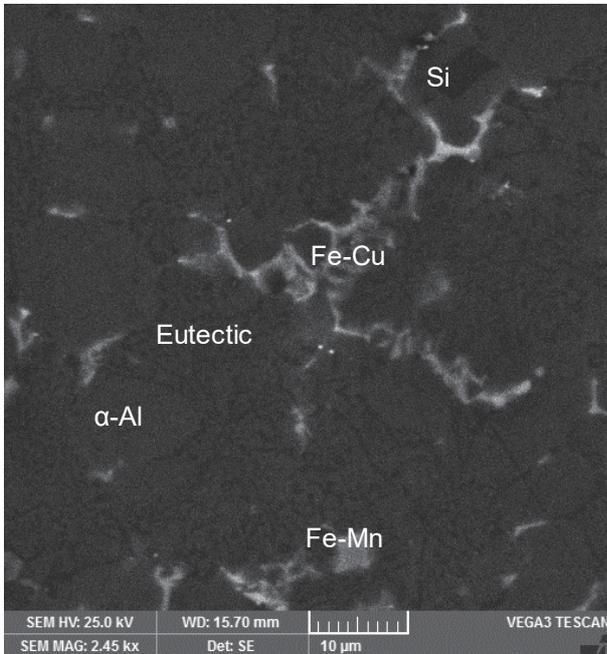
There was a network of fine particles with higher Cu and lower Fe content along dendrite boundaries, and two kinds of larger individual particles were found inside the α -Al dendrites. Several dark sharp edged particles of primary Si were observed inside the dendritic areas and occasionally sharp edged light grey particles rich in Fe and Mn, with Fe:Mn ratio around 2:1 (**Figs. 6 - 7**).

Fig. 6 Dendritic microstructure of the fork with interdendritic eutectic network, particles at dendrite boundaries (Fe-Cu) and two kinds of larger particles inside dendritic areas (primary Si and Fe-Mn)

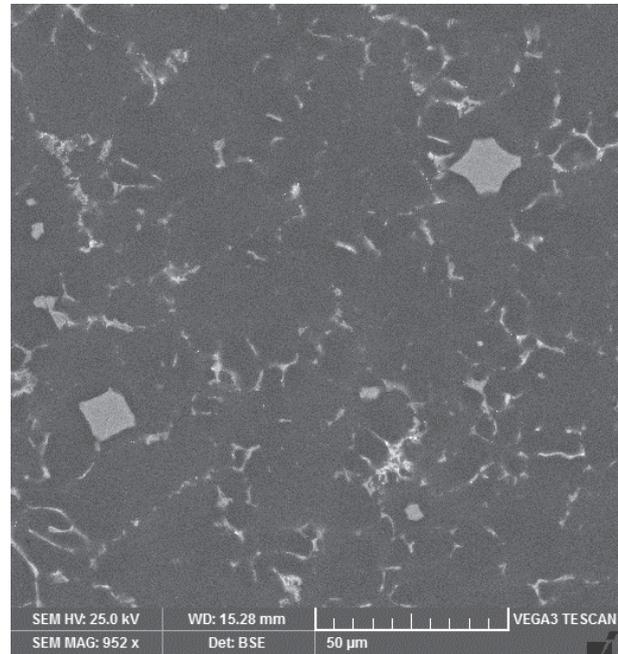
Fig. 7 Detail of light iron-copper phase at dendrite boundaries and light iron-manganese sharp particles in BSE mode

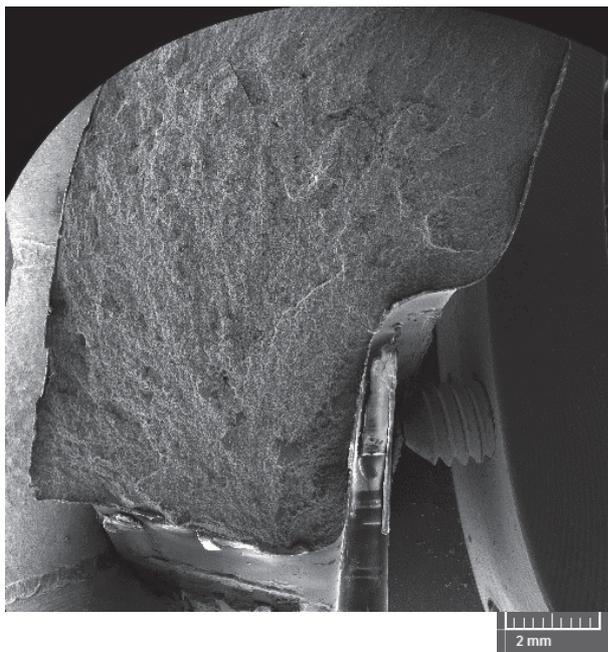
Fig. 8 Fracture initiation area at the surface of the fork, larger shrinkages visible.

Both fracture surfaces were observed using a scanning electron microscope. The initiation of the fracture was just under the surface of the thinner part of the fork (**Fig. 8**). The characteristic appearance of shrinkage casting dendrites is clearly evident and it is in agreement with the microstructure features (**Fig. 9**). Brittle fracture areas, sometimes with oxidised surfaces, were observed in the shrinkages. The fracture surface between the shrinkage porosity exhibited a dimple rupture character. No evidence of progressive fatigue failure was observed anywhere on the fracture surface.

It can therefore be concluded that the dimple rupture fracture surface was the result of sudden impact, overload failure. Even though Al-Si alloy was a suitable type of material for this application and the addition of iron further improved its impact resistance and endurance limit, the presence of shrinkage and porosity resulted in significant decrease of the real cross section of the part, thus contributing to the overload of the remaining volume of material.

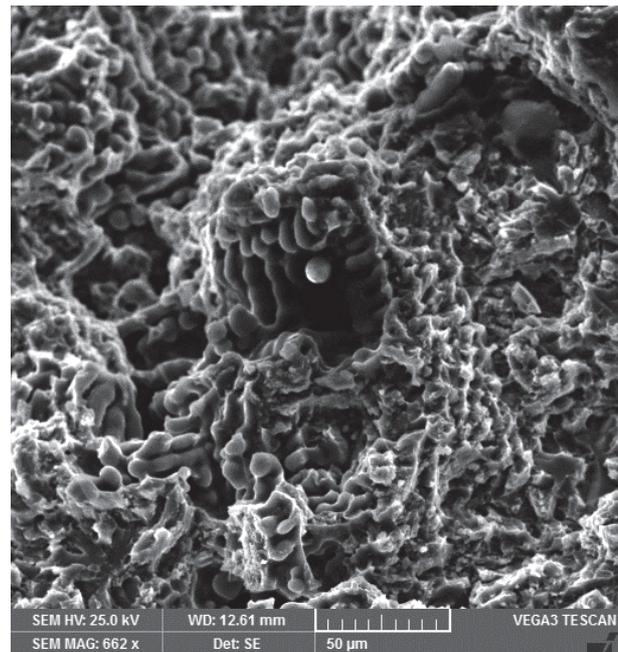
Fig. 9 Dendrites on the fracture surface
