CASE STUDY OF DEFECTS ON VITREOUS ENAMEL COATING

¹Kateřina KREISLOVÁ, ¹Markéta VLACHOVÁ, ¹Hana GEIPLOVÁ

¹SVÚOM Ltd., Prague, Czech Republic, EU, kreislova@svuom.cz

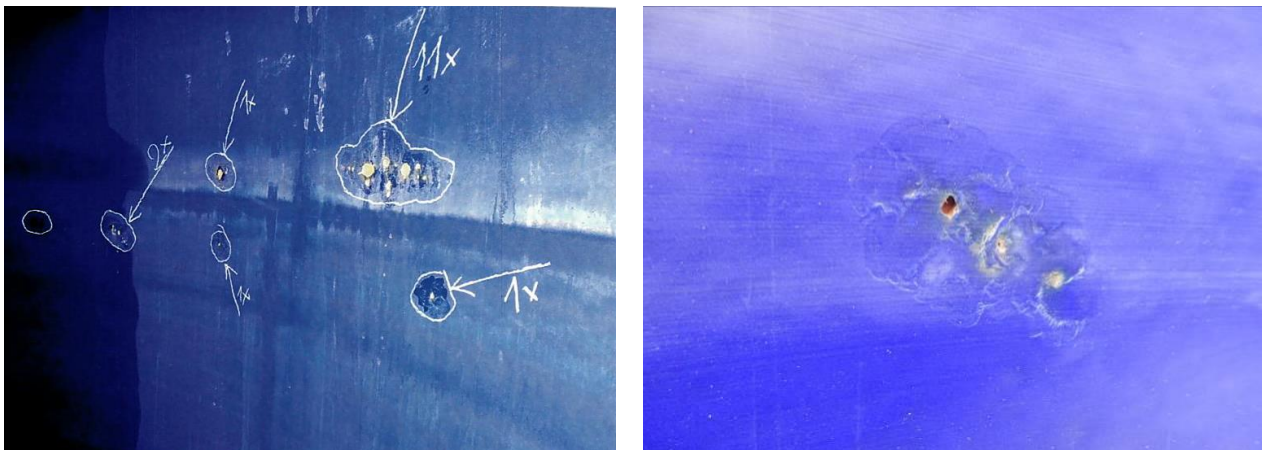
Chemical reactor was used for 5 years for preparation of dilute sulphuric acid solution. The enamel coating was applied on inner surface with the thickness from 1370 to 1690 μm .

On the inner surface there are local defects in the enamel coating (ISO 19496-2) - chipping of part of the enamel layer around the holes in the coating, under which intense corrosion attack has occurred (**Figure 2**). The size of the defects is very different from holes with a diameter of about 5 mm to a large hole with a diameter of about 100 mm. In the place of defects, the enamel coating is sufficiently adherent to the underlying steel - it does not spontaneously peel off from the underlying steel. The enamel coating is under-corroded at the point of the defects - corrosion damage to the steel extends below the enamel layer in depth and width.

Figure 2 The example of defects on inner surface of chemical reactor

In the chipped layer there were found cracks. The coating was disturbed to a depth of ca 100 to 300 μm by gradual dissolution of the layer. The rate of gradual dissolution of the enamel can be estimated at about 0.05 mm/y, but it was slower than the values specified for enamel resistance in common acids. According to EN ISO 28721-2 have enamel coatings on fittings, pipes, pumps, mixers and other equipment in the chemical industry meet the quality requirements: thickness of coating 1.0 to 2.2 mm, temperature to crack forming $\geq 190^\circ\text{C}$, corrosion rate 0.08 mm/y at hydrochloric acid and corrosion rate 0.40 mm/y at sodium hydroxide.

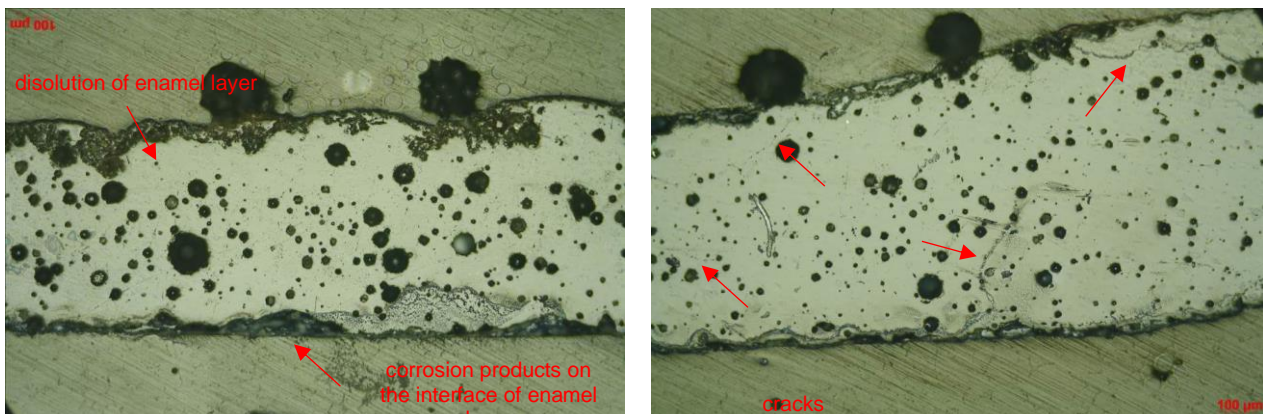
Figure 3 The bubbles and cracks in the chipped enamel layer

The porosity was tested by high-voltage test - at 12 kV the pores occurred on defects' areas and at 15 kV the pores occurred on whole area. The cross section of chipped enamel layer shows cracks in it (**Figure 3**). The chemical analysis of this layer shows the changes of its composition due to dissolution by chemical attack.

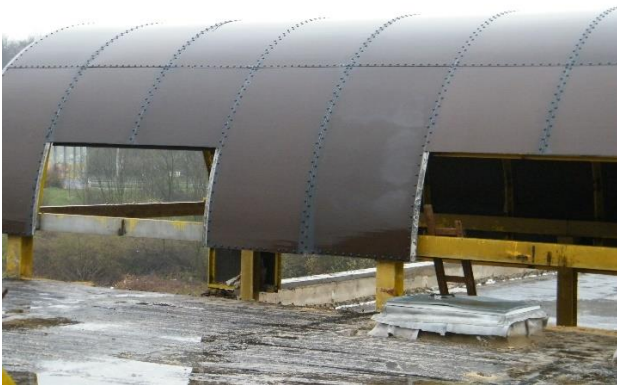
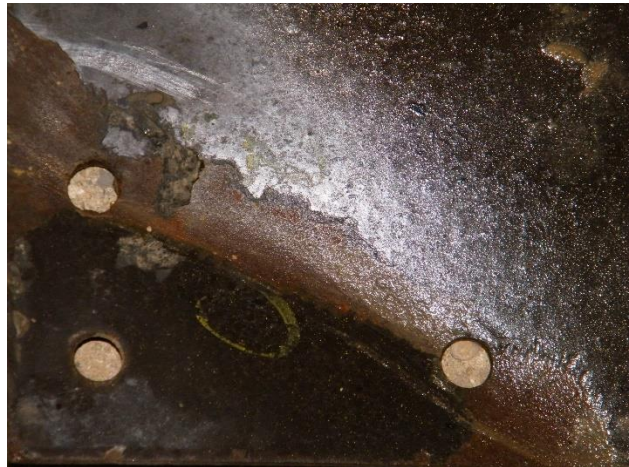
For part of roof of swimming pool Sutka, Prague, the sheet with enamel coating were used (originally the silo and similar tanks are produced from these sheets). The construction was suspended for 20 years. The condition of these sheet was control before the completion of the construction. The enamel coating was damaged on the cutting edges and around the screws' holes where the layer was cracked and chipped, substrate steel corroded (**Figure 4**). Remaining surface was without any defects. The local defects were repair and sheets are still served as roof, now for 12 years.

Figure 4 The typical defects on roof sheets after 20 years

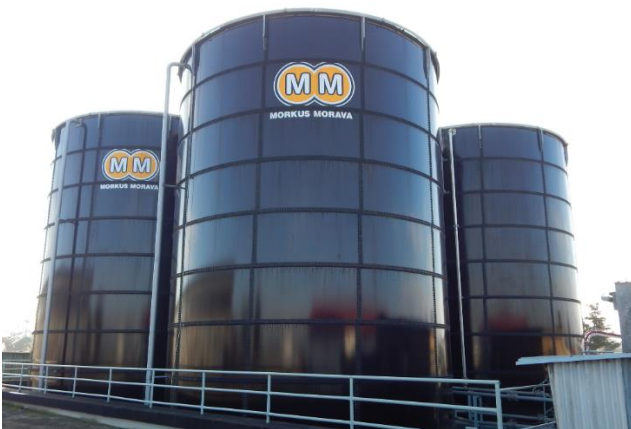
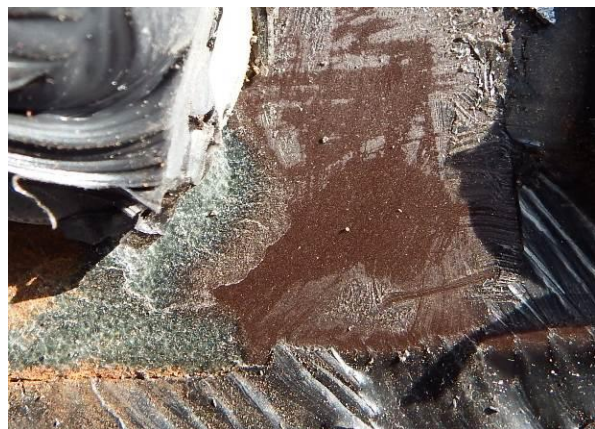
Figure 5 The evaluated storage tanks

The enamel sheets for cylindric storage tanks for chemical fertilizers was other evaluated objects. The damage of coating - chipping - was found after 1 year of exposure on the inner and outer surfaces around the screws' holes - **Figure 5**. On these areas the steel corrosion occurred. Thickness of coating was ca 465 μm on the

both side on surfaces without damage. On the damaged areas the coating thickness was ca 250 μm . The porosity of coating was measured by high-voltage test according by EN ISO 2476 at 2 900 V - the test does not prove any defects.

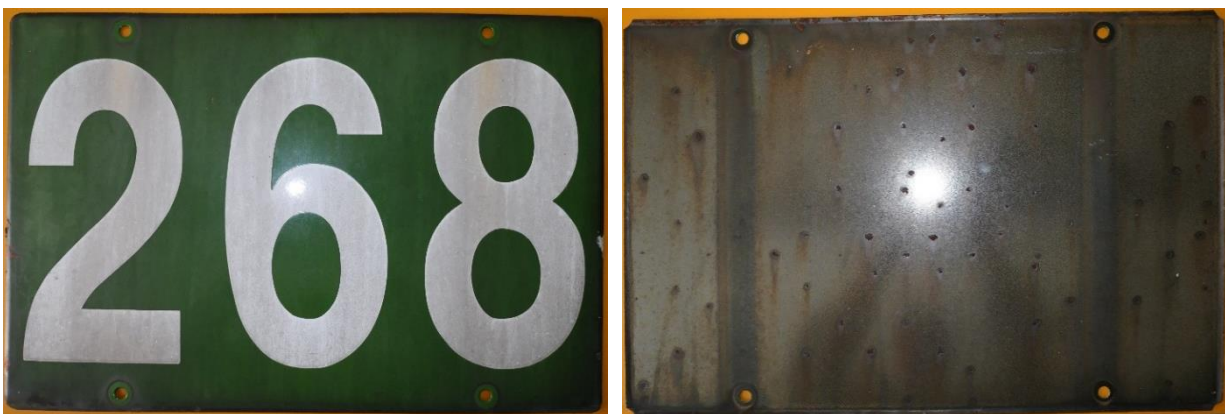
One of example is the sign table from electric pole after 20 years exposure at atmospheric conditions (**Figure 6**). The defects occurred on the edges and on the back side of table. There are many large open pores from which the corrosion of substrate steel spreading. The enamel coating thickness is 250 to 320 μm on the front side depending on the color of layer and only 133 μm on the back side.

Figure 6 The evaluated sign table

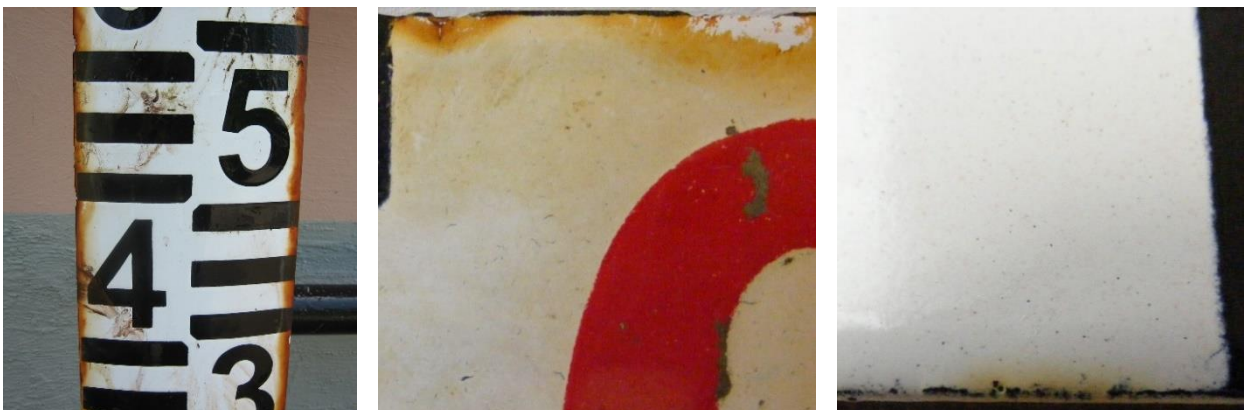
The same defects were found on the special tables used for water level measuring in river Elbe. After 1 year of service intensive steel corrosion occurred on the edges of tables (**Figure 7**). The enamel coating thickness was nonuniform and varies from 280 to 395 μm of white coating on the front side and from 50 to 195 μm of black coating on the back side of tables. The thickness of the enamel coating for the water environment should vary from 100 to 500 μm , depending on the water corrosivity.

The low-voltage test was performed with a porosimeter Elcometer 270. A voltage of 67.5 V was used for measuring coatings with a thickness greater than 300 μm . On the front side, pores and defects in the continuity of the coating were indicated only rarely - ca 3 - 5 pores on the edge of each sample. The number of pores even on the back side of all battens exceeds the recommended value of 5 pores/1 m^2 of surface area (EN 14431).

Figure 7 The typical defects on tables
