# ANALYSIS OF LACK OF STABILIZATION OF THE CEMENTLESS ACETABULAR CUP OF THE ENDOPROSTHESIS HIP JOINT – MATERIAL ASPECT

### https://doi.org/10.37904/metal.2021.4197

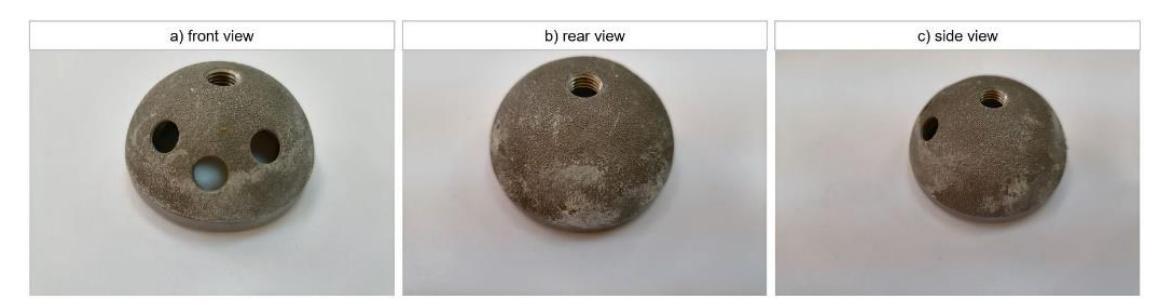
In the first stage of research, the structure of the deimplanted cementless acetabular cup was analyzed. **Figure 2** shows macroscopic photos of the examined implant. The conducted research revealed the places of surface violation of the implant resulting from the intraoperative removal of the acetabular cup from the bone bed. No features of the implant surface overgrowth with bone tissue were revealed. In order to visualize the components of bone tissue, research were carried out using the stereoscopic microscope OLYMPUS SZ61 – the results are presented in **Figure 3**. On the surface of the deimplanted acetabular cup, fragments of bone tissue were revealed, but only in a few places. The complete coverage of the implant with bone tissue and the

features of the overgrowth of the implant were not visualized. The resulting bone tissue clusters were uneven and discontinuous. Large areas on the implant surface were revealed with no signs of coating.

Figure 2 Macroscopic photos of the acetabular cup surface: (a) front view, (b) rear view and (c) side view

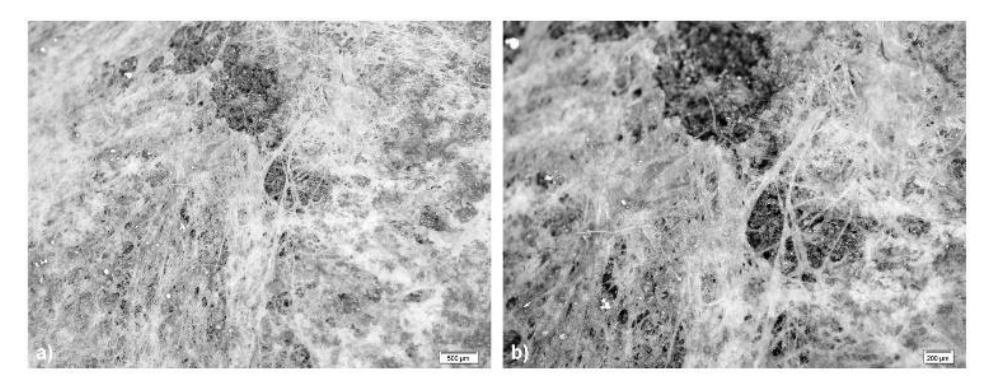
Figure 3 Selected fragments of the surface of the deimplanted acetabular cup

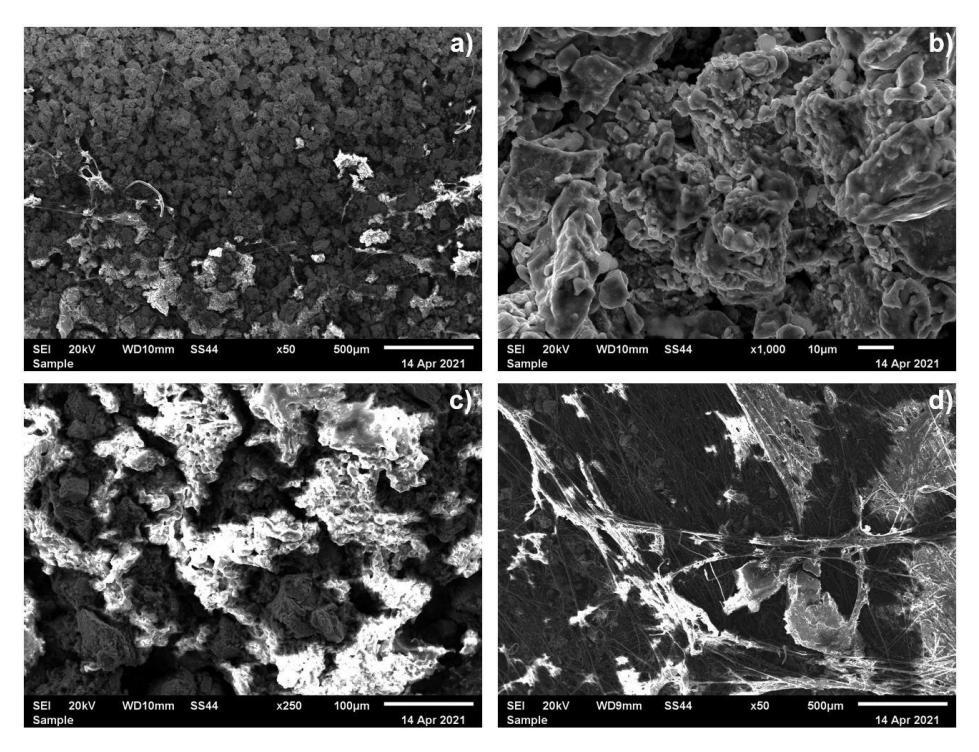
Figure 4 Photos of microstructures in selected places of the examined acetabular cup: (a) the boundary between the acetabular cup surface without bone tissue from the surface with visible bone tissue, (b) microstructure of the titanium coating, (c) visualized bone tissue – 250x magnification and (d) visualized bone tissue – 50x magnification

The next stage of the research was to analyze the microstructure of the tested element. The obtained results are presented in (**Figure 4**). Using a scanning electron microscope with an EDS type X-ray microanalyzer, the chemical composition of the acetabular cup was analyzed in places covered with bone tissue and on the clean surface. **Table 2** shows the results of the chemical composition of the titanium surface without bone tissue cover, while **Table 3** shows the chemical composition of the visible elements of bone tissue. The chemical

composition of the material remaining on the acetabular cup after reoperation confirms that it is bone tissue. However, the scant amount of material found indicates that there was no osseointegration and no secondary stabilization. Secondary stabilization occurs when bone tissue begins to overgrow the porous struture of the outer acetabular cup surface. After three years, most and often even the entire surface of the porous structure should be covered with bone tissue – however, this was not the case here. Next, the analysis of the acetabular cup phase composition was performed using a SEIFERT T-T X-ray diffractometer. **Figure 5** shows the diffractogram obtained for the examined acetabular cup of the hip joint. The X-ray diffractogram obtained for the acetabular cup revealed the presence of Ti<sub> $\alpha$ </sub> and Ti<sub> $\beta$ </sub> phases.

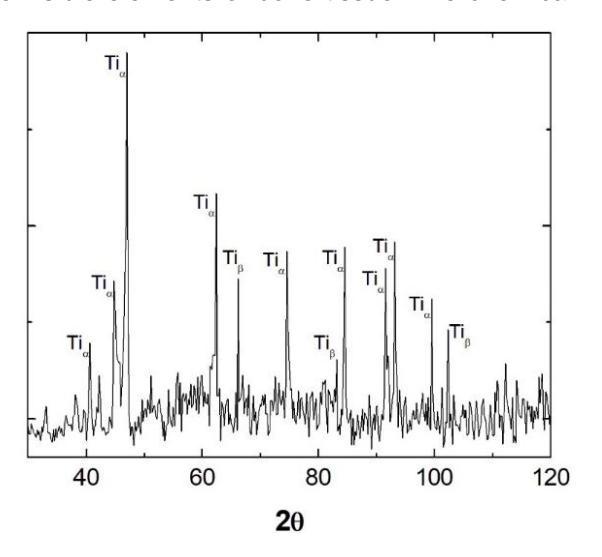
Figure 5 The diffractogram obtained for the tested acetabular cup
