## WEAR PROGRESS OF EXCHANGEABLE CUTTING INSERTS DURING Ti<sub>6</sub>Al<sub>4</sub>V ALLOY MACHINING

PETRŮ Jana, SCHIFFNER Jan, ZLÁMAL Tomáš, ČEP Robert, KRATOCHVÍL Jiří,  
STANČEKOVÁ Danka

*VSB - Technical University of Ostrava, Faculty of Mechanical Engineering, Department of Machining,  
Assembly and Engineering Metrology, Ostrava, Czech Republic, EU*

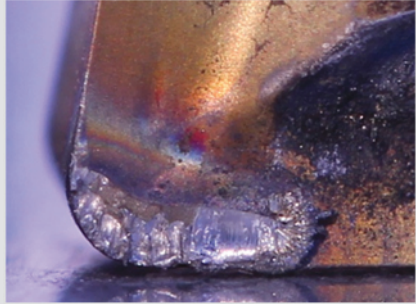
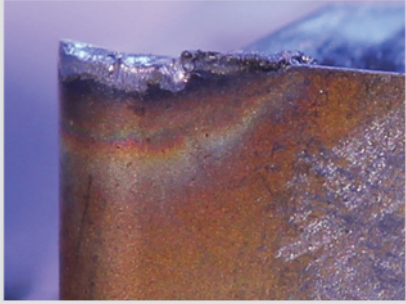
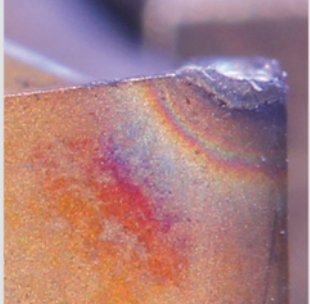
**Table 3** Wear of the tool cutting edge

<b>CNMG 120408-SM, T8315</b>		
$t_{As} = 14 \text{ min}$		$VB_C = 410 \mu\text{m}$
Rake face	Flank face (major cutting edge)	Flank face (minor cutting edge)

Amplitude of the flank wear in the area of the tool tip  $VB_C$  and the wear in the form of a groove on the rake face of inserts can be easily seen in the below photo documentation. The highest durability during machining of the Ti<sub>6</sub>Al<sub>4</sub>V Titanium alloy was demonstrated by exchangeable cutting inserts with T8315 and 9605 coatings.

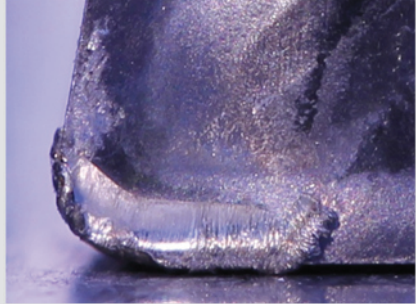
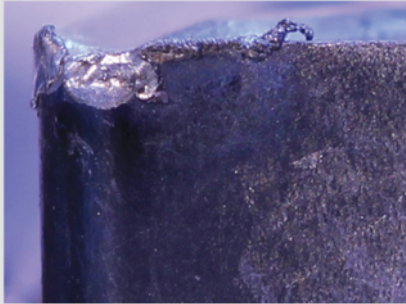
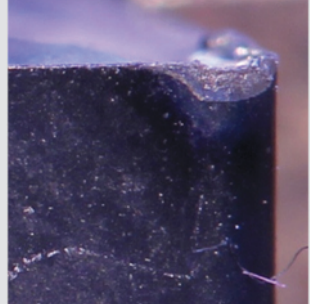
**Table 4** Wear of the tool cutting edge

<b>CNMG 120408-M5, 9605</b>		
$t_{As} = 14 \text{ min}$		$VB_C = 655 \mu\text{m}$
Rake face	Flank face (major cutting edge)	Flank face (minor cutting edge)

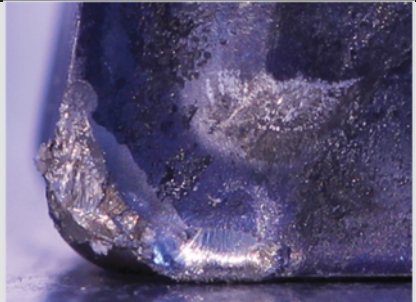
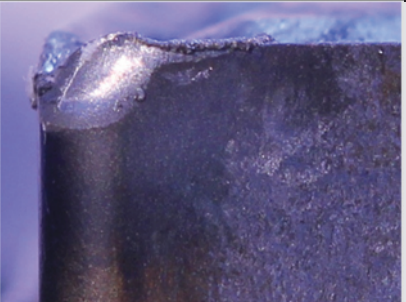
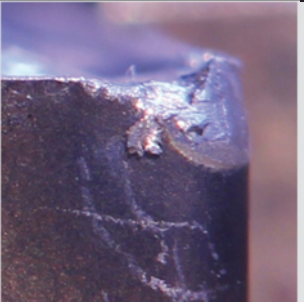
**Table 5** Wear of the tool cutting edge

<b>CNMG 120408-NRS, WSM20</b>		
$t_{As} = 9 \text{ min}$		$VB_C = 810 \mu\text{m}$
Rake face	Flank face (major cutting edge)	Flank face (minor cutting edge)

The worst results during machining of Titanium alloy were reached by the CNMG 120408 - NRS exchangeable cutting insert with WSM20 coating. The critical wear value VB<sub>C</sub> = 500 μm at the tip area was reached within 9 minutes. Durability of this cutting tool can be achieved by modification of cutting conditions or by proper selection of abrasion resistant base and coating always in combination with a suitable cutting geometry of the tool. The best results were achieved with the CNMG 120480 - SM cutting tool with T8315 coating and the CNMG 120408 - M5 tool with 9605 coating. Durability of these cutting tools under given cutting conditions was around 14 minutes. However, wear in the tip area was more intensive with the CNMG 120408 - SM cutting tool with T8315 coating, which could have been caused by the combination of basic base material and coating substrate or by their chemical composition.

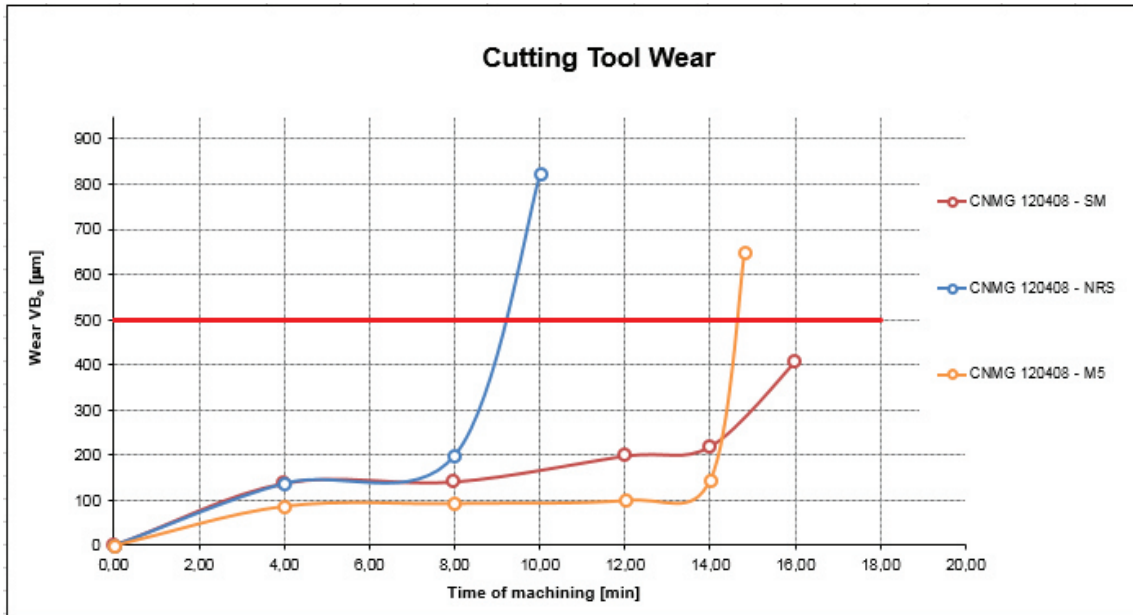
Chart 1 The progress of wear at the area of tool tip VB<sub>c</sub>

In order to determine the amplitude of tool cutting wear the wear in the area of tool tip, where the tool is worn the most intensively, was measured during machining of the  $Ti_6Al_4V$  Titanium alloy.  $VB_{opt} 500 \mu m$  was set as the wear criterion for determination of the insert durability. Also the width of a crater on the rake face  $KB$  was measured after the set interval together with the measurement of the amplitude of tool flank wear progress.

CNMG120408-SM		CNMG 120408-M5		CNMG120408-NRS	
$t_{As}$ [min]	$VB_C$ [ $\mu m$ ]	$t_{As}$ [min]	$VB_C$ [ $\mu m$ ]	$t_{As}$ [min]	$VB_C$ [ $\mu m$ ]
4.00	138	4.00	87	4.00	138
8.00	141	8.00	93	8.00	201
12.00	198	12.00	100	10.00	825
14.00	219	14.00	146		
16.00	407	16.00	649

It is apparent from the exchangeable cutting insert wear measurement results, that during machining of the Ti<sub>6</sub>Al<sub>4</sub>V Titanium alloy, the critical demonstration of the cutting edge is the wear in the area of the tool tip VB<sub>C</sub>. The wear in the area of the tool tip was caused primarily by machining of the strengthened layer of material, where the tip of the cutting edge is exposed to the combination of very intensive mechanical and heat loads.
