## IDENTIFICATION OF DEFECTS ON NiDi COATING

### Abstract

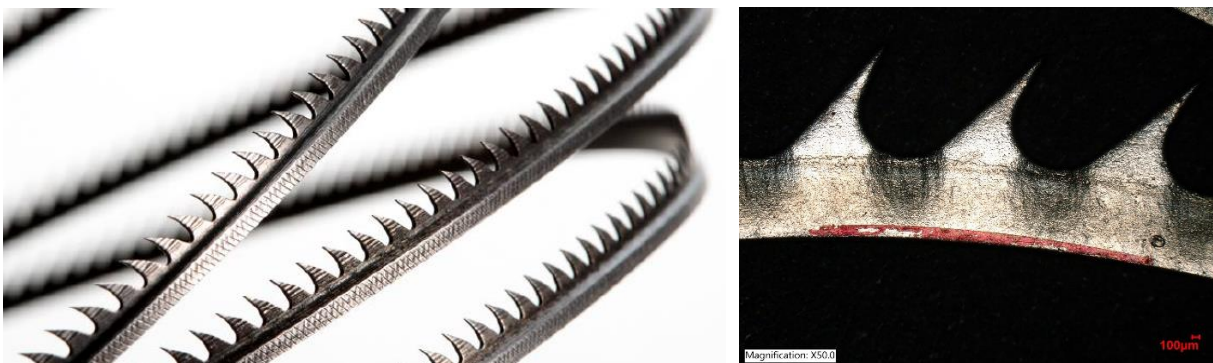
**Figure 3** Example of wire and detail of coating

Metallic wire is a wire made of metal which has saw tooth shape, and combs fibres on the process of carding in manufacturing of fabric (**Figure 3**). Surfaces in contact with fibres, in particular, are protected effectively against wear. The wires are treated with special smooth coating to obtain corrosion protection for the use in humid conditions. Electroless nickel and electroplated nickel dispersion coatings have been used successfully in textile machinery construction for decades [11].

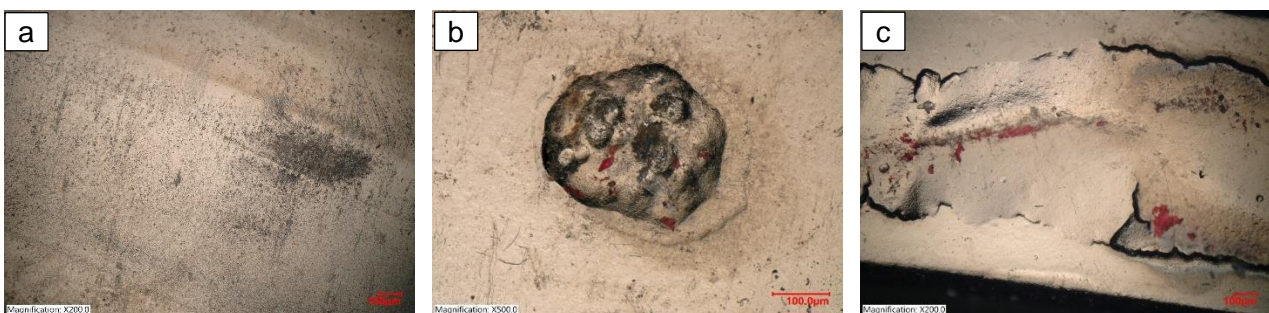
**Figure 4** Examples of defects on NiDi coating (sample B)

The NiDi coating was applied on special wire for textile industry. Two samples were evaluated: reference **sample A** without defects and **sample B** on which the coating showed a lot of defects (**Figure 4**) documented with 3D optical microscope Keyence VHX 5000:

- black spots and stains (**Figure 4a**),
- blisters (**Figure 4b**),
- overlapping layers which partly delaminated (**Figure 4c**).

The overlapping was connected with doubled layer. This defect is caused by bath contamination – that can be prevented by bath filtration each 1 to 2 weeks.

The height of numerous spots with grape-like "blisters" reached approximately 55  $\mu\text{m}$ . Deposit blisters can arise from poor surface preparation, an over-stabilized electroless bath or dragging contaminated rinses into the bath.

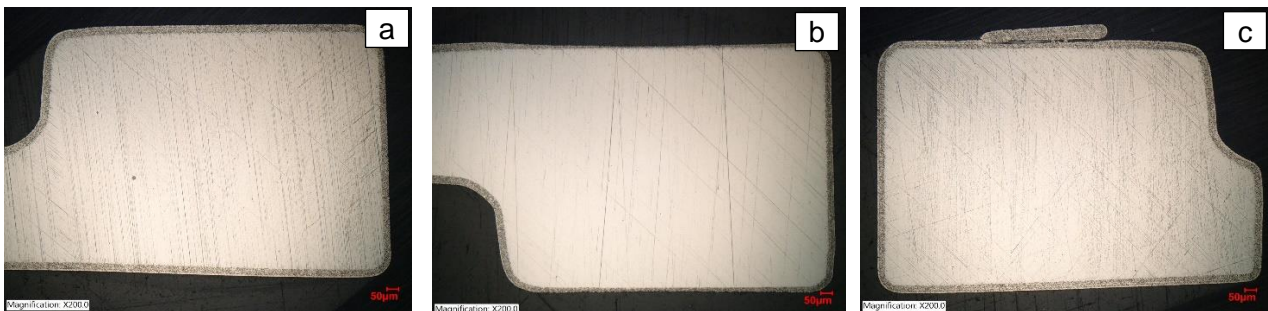
**Figure 5** Examples of NiDi coating cross sections

The coating layer thickness was measured on the cross sections of wires. On wire without defect (A) the coating layer was distributed uniformly (**Figure 5a**). The coating thickness of evaluated coating varied from 10 to 30  $\mu\text{m}$ . The structure of the NiDi coating guarantees the good adhesion.

On wire sample B with defects the coating was distributed nonuniformly (**Figure 5b, 5c**). The layer thickness was reduced to 3 – 4  $\mu\text{m}$  within the areas of black stains. Non-uniform deposits can be the result of out-of-range electroless bath operating parameters and insufficient surface preparation.
