CORROSION OF HOUSEHOLD MIXER HEADS

Keywords: Crevice corrosion, stainless steel, mixer heads

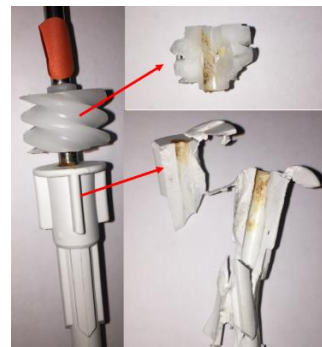
The mixer heads had visible corrosion products on the polymer/steel contact as shown in **Figure 1.** We cut the mixer heads lengthwise through the head to measure the width of the gap between the plastic and steel. We also made a longitudinal cross-section of the stem for microstructural analysis and visually inspected the areas under the polymer. The visual inspection showed that the corrosion appeared only on the polymer – steel interphase as seen in **Figure 2**.

**Figure 1** Corrosion on the steel–polymer bond

Figure 2 Visible corrosion under the polymer

The corrosion occurred only on the polymer-steel interphase.

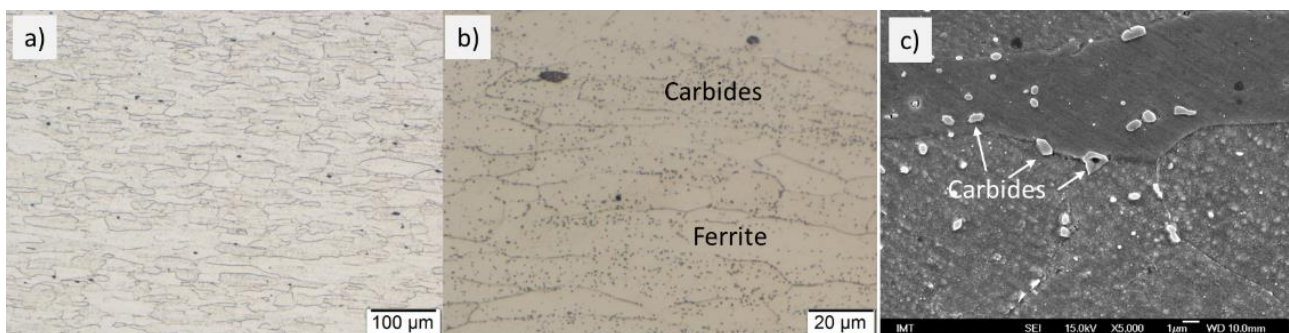
No significant irregularities were detected in the microstructure. The microstructure of the 1.4016 stainless steel consisted of ferrite with precipitated chromium carbides. The grains were elongated in the direction of forming, with a length of about 100 µm and a width of 20 µm, as shown in **Figure 3**. The sample chemical composition is consistent with 1.4016, the specifications for chemical composition and the chemical analysis are given in **Table 1**.

Figure 3 Microstructure of 1.4016, a) elongated ferritic grains, b) ferrite grains and carbides, c) Carbide precipitates along grain boundaries and within grains

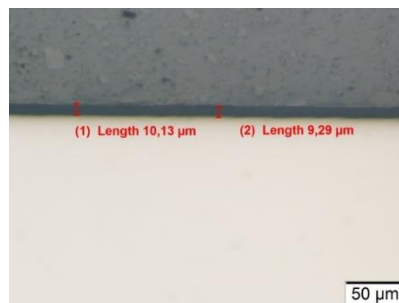
The gap width between the plastic and steel was 9-10 µm in both cases, as shown in **Figure 5**.

Figure 5 Gap between the steel and polymer

Based on the performed analyses, we can confirm that crevice corrosion has occurred. The gap between the polymer and the stainless steel provided the conditions for crevice corrosion. The gap width of 10 μm is sufficient for corrosion to occur.

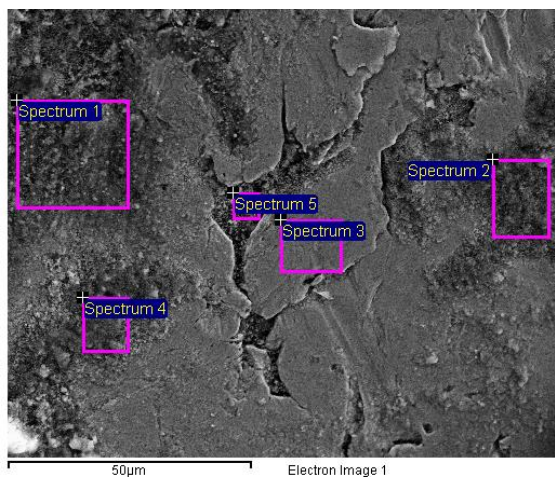
EDS analysis of the corrosion product (1.4021) in **Figure 6** showed an increased content of chlorine and sodium (**Table 3**), which is typical for crevice corrosion. The oxides also contained a lot of iron, which is why the product was reddish in colour. For comparison of microchemical EDS analysis and surface morphology, a non-corroded 1.4021 surface on the same mixer head is shown (**Figure 7** and analysis in **Table 4**). The SEM-

Figure 6 SEM-EDS analysis of corrosion product on steel 1.4021

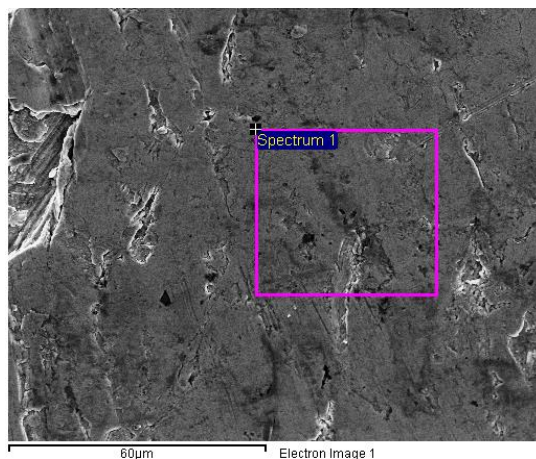
EDS analysis of the surface deviates from the bulk chemical analysis, showing higher Cr and lower Si and Mn, we also included O in the analysis to show a normally passivated surface.

Figure 7 SEM-EDS analysis of an uncorroded surface on the mixer head

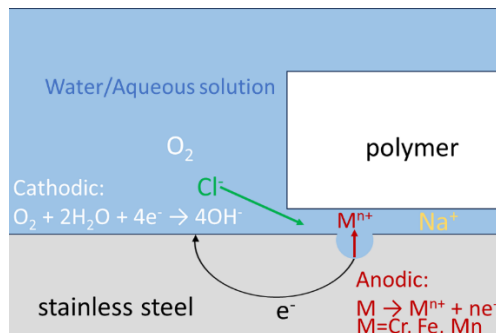
Figure 8 Schematic representation of crevice corrosion

The hydrochloric acid destroys the passive film (chloride attack) and accelerates the dissolution of the metal inside the crevice. Meanwhile, the cathodic reduction remains restricted to the areas outside the crevice that remain protected. **Figure 8** shows schematic crevice corrosion.
