# ANALYSIS OF LACK OF STABILIZATION OF THE CEMENTLESS ACETABULAR CUP OF THE ENDOPROSTHESIS HIP JOINT – MATERIAL ASPECT

### https://doi.org/10.37904/metal.2021.4197

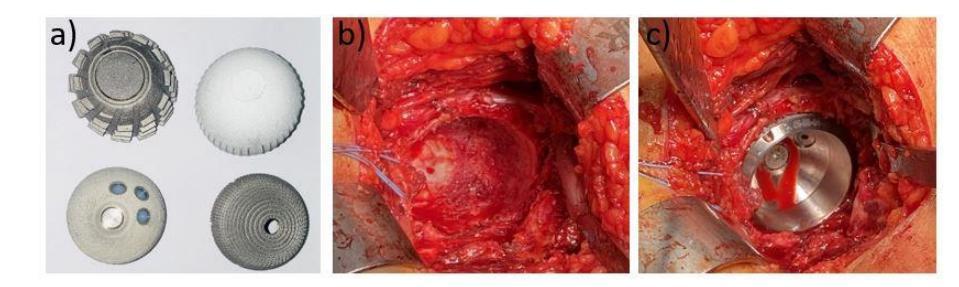
Figure 1 Macroscopic photos showing: (a) examples of cementless acetabular cup types, (b) properly prepared bone bed and (c) embedded cementless press-fit acetabular cup
