THE INFLUENCE OF ADDITIONAL PROCESSING AFTER OXY-ACETYLENE CUTTING ON THE STRUCTURE AND CORROSION RESISTANCE OF THE ZINC COATING

Abstract

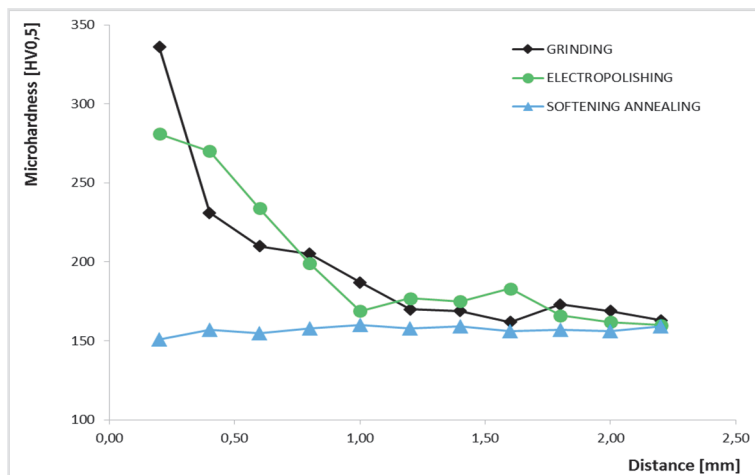
- 158 HV10. In the second stage the hardness measurement (HV0.5) was made starting from the cutting edge toward the sample core. The step of the measurement was established on 200 μm. Results are presented in Fig. 1.

Fig. 1 Results of hardness measurement (HV0,5) on the side surface of links in direction from cutting edge to the sample core

Metallographic analysis and the hardness measurements confirmed that the hardness increase after application of thermal cutting methods is totally reasonable. The initial hardness of S355JR steel was about 155 HV10. The research shows that cutting with OAB results in hardness increase to the level of 352 HV10 (**Fig. 1**). Application of softening annealing causes hardness reduction to the level 157HV10, however in case of other tested methods the hardness is equal correspondingly to A- 329 HV10 and C- 299 HV10.
