ISSUES IN MACHINING EPOXY RESIN - NANO REINFORCEMENT COMPOSITE SYSTEMS WITH RESPECT TO SURFACE INTEGRITY AND TOOL WEAR

Abstract

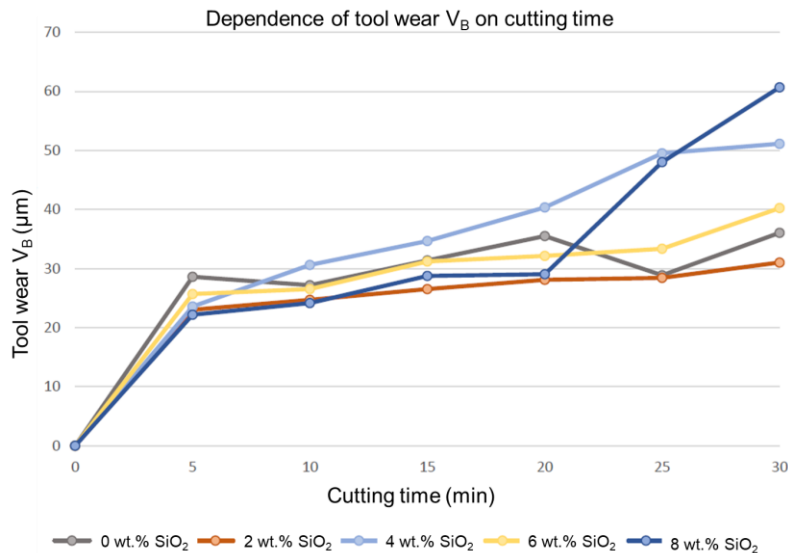
Figure 2 Summary graph of achieved V_B parameter values for individual samples

The sample without the addition of reinforcing nanoparticles, Sample 1, acts as a basic reference for the observation of the observed parameters. It is therefore a pure epoxy resin made according to the methodology presented in Chapter 2. **Figure 2** shows the processed values of the observed tool wear parameter V_B for machining samples with 0, 2, 4, 6 and 8 wt.% SiO_2 . Similar is the case for **Figure 3** for the parameter R_a . The individual plots will be described within the sub-sections corresponding to the sample under examination.

In **Figure 2** the wear development of the tool can be observed. When the sample was machined without the addition of nanofiller, almost 80% of the total wear occurred within the first 5 minutes of milling. The wear trend was of increasing character, except at the points corresponding to 10 and 25 minutes in the cut. These decreases were due to the difficulty in positioning the microtool to the initial measuring positions and the presence of post-machining debris (chip clusters) that can visually act as cutting tool material. The dependence of roughness on tool time in cut for Sample 1 (**Figure 2**) shows a slight increasing trend along with increasing magnitude of V_B wear. This can be explained by the area of the sample in which the material may have been ploughed resulting in an increase in the surface roughness, by the deposition of a larger amount of very fine particles of chips or by the greater presence of cavities in the sample. The machining cycles revealed the presence of cavities in the sample (**Figure 4a**), that were created during the production of the blanks for the experimental part, e.g. by insufficient venting during casting. These cavities may increase tool wear due to the interruption of smooth tool engagement. Furthermore, a material surface can be observed where, due to tool wear, ploughing of the material has started to occur and the chip thus separated has then attached to the machined surface (**Figure 4b**). The machining of the specimen, which contains only epoxy resin, produced worm-like chips (**Figure 4c**). The same chip morphology was present during the last machining cycle.

As with Sample 1, the greatest wear occurred during the first machining cycle, with approximately 74 % of the total wear (**Figure 2**). The trend of the curve is increasing and the differences between the measured sections are almost constant. Contrary to expectations, the total wear is approximately 5 μm less than the tool that milled the sample without nano-reinforcement. A regular increase in R_a values can be observed in the roughness plot (**Figure 3**). However, it is clear from the roughness measurements that the resulting surface of Sample 2 has lower R_a values than Sample 1. When machining the samples with SiO_2 addition, it was possible to observe clusters of undispersed nanofiller (white areas) in addition to cavities (black areas) (**Figure 5a**). The quality of the machined surface and the recognizability of the toolpaths also rapidly decrease due to the increasing magnitude of tool wear (**Figure 5b**). After adding 2 wt.% SiO_2 , the character of the resulting chips did not change much. Their shape is still worm-like. After the last machining cycle, i.e. 30 min, there was a relatively large change in the nature of the chips. Due to tool wear, the shape of the chips changed from worm-like to a crumble shape, which forms accumulations of chips (**Figure 5c**).

For Sample 4, most of the wear can be observed to occur within the first 5 minutes of machining. In the case of this sample with 6 wt.% SiO_2 , this represents the formation of approximately 64 % of the final measured V_B size. The rest of the graph shows a slightly increasing trend (**Figure 2**). For this sample, it is possible to observe regularly increasing values of roughness R_a (**Figure 3**). In **Figure 7a**, many white regions representing non-dispersed clusters of nanofiller revealed by the 4th machining cycle can be observed. The size of said clumps relative to the toolpaths can be observed in **Figure 7b**. These randomly distributed clusters contribute significantly to the increase in the magnitude of the V_B wear and the magnitude of the roughness parameters. As the amount of nanofiller increases in the sample structure, it is evident that the filler contributes significantly to the friability of the chip. In **Figure 7c**, it can be observed that even though the chips are flake shaped, there are areas around and between the chips that are crumbly in nature. As the tool wears, the chips change from a flake shape to an almost completely friable shape, forming very small particles.

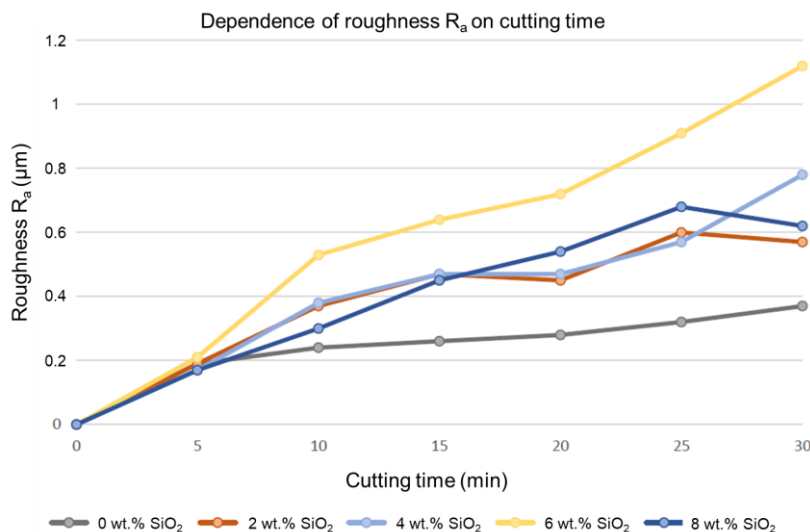
Figure 3 Summary graph of achieved R_a parameter values by each sample

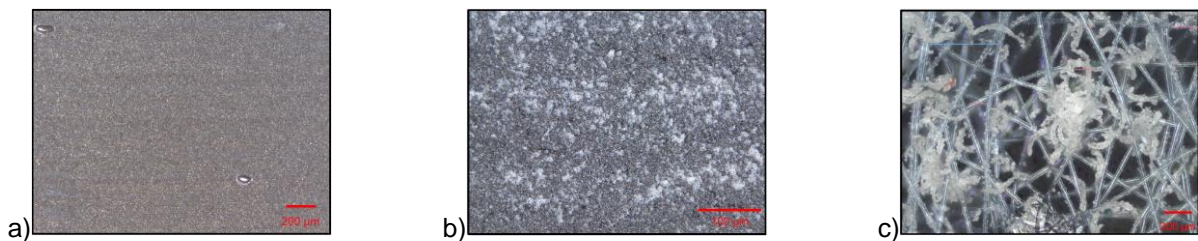
Figure 4 Overall overview of Sample 1. (a) Occurrence of cavities on the surface.; (b) Surface after 30 minutes of the tool in the cut.; (c) Nature of the chips formed – white areas.
