## DISC LASER WELDING OF Mg ALLOY AZ61A

### Abstract

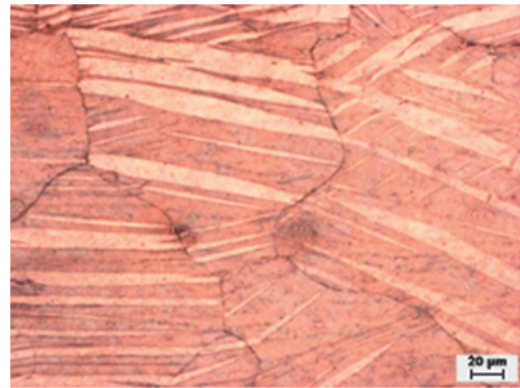
AZ61A consists of 2 phases - delta phase, i.e. solid solution and gamma precipitate -eutectic Mg<sub>17</sub>Al<sub>12</sub>. Precipitates of gamma phase are 3x harder than delta phase. After casting, welding, these are at the grain boundaries, so Mg alloys should undergo heat treatment to improve properties. In **Fig. 2** matrix of delta phase with fine intermetallic particles (black dots) is visible.

Fig. 2 Microstructure of AZ61A

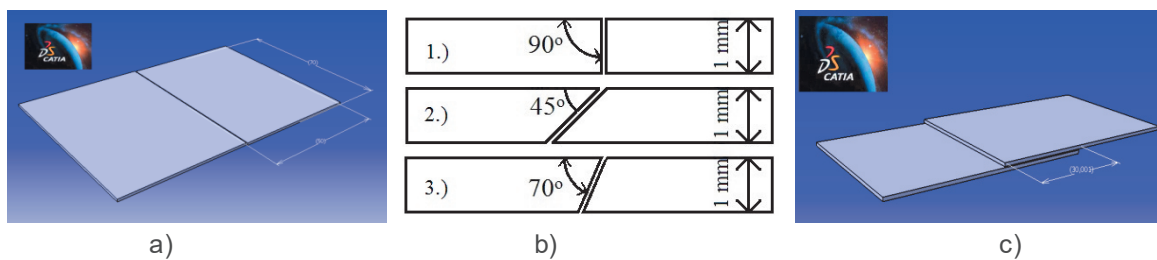
**Fig. 3** Weld joint: a) butt joint - 3D model b) variations of butt weld edges: 1) milled edge, 90° angle, 2) milled with 45° angle, 3) milled with 70° angle, c) 3D model of lap weld

For 1 mm thick sheets butt welds and lap welds were prepared, as in **Fig. 3a, b, c**.

Firstly, the samples for butt welding of size 70 mm x 50 mm were prepared by shearing. Generally for steel materials, shearing of sheet metal as preparation for laser welding is satisfactory as the ductile material shearing edge deformation is advantageous. By an experiment, the as sheared edge quality (in **Fig. 4a, b**) proved unsatisfactory as it led to burn through, as in **Fig. 4c**. This was caused by brittle shearing of Mg alloy, **Fig. 4a**, and inability to assemble sheets close enough, **Fig. 4b**. For butt welding, the root gap has big importance. Especially for autogenous welding without filler wire, the minimum gap of 0.1 - 0.2 mm is needed. The as sheared weld edge led to unacceptable weld, so further milling with several angles was applied to improve welding results, **Fig. 3b**.

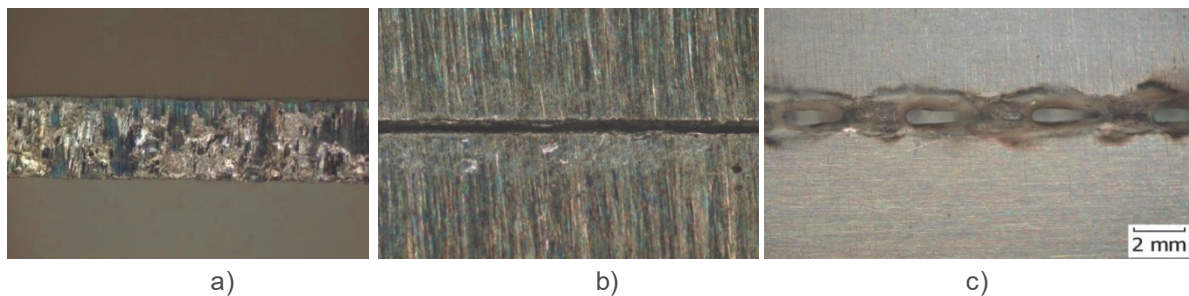
**Fig. 4** As sheared samples, a) sheared edge, b) butt weld assembly, c) weld with sheared edges ( $P = 600 \text{ W}$ ,  $f = +5 \text{ mm}$ )

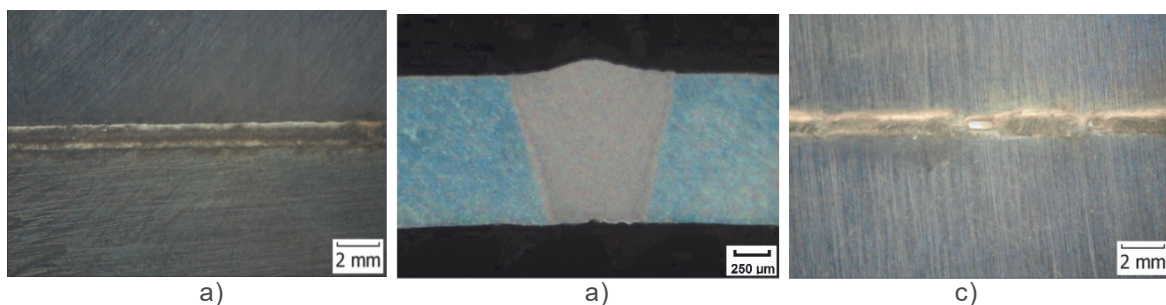
The sample with edges milled perpendicularly, welded with parameters  $v = 80 \text{ mm}\cdot\text{s}^{-1}$ ,  $P = 650 \text{ W}$ , shielding by  $4.6 \text{ Ar}$   $12 \text{ l}\cdot\text{min}^{-1}$ , root  $4 \text{ l}\cdot\text{min}^{-1}$ , at focus, are shown in **Fig. 5a**, these are the most optimum parameters found. High quality joint, full penetration, no porosity, without spatter and underfill was reached, **Fig. 5b**. Increasing the power to  $P = 750 \text{ W}$  led to burn through, as in **Fig. 5c**.

**Fig. 5** Butt joint - perpendicular milled edges, a)  $P = 650 \text{ W}$ ,  $v = 80 \text{ mm}\cdot\text{s}^{-1}$ , b) macrograph, c) at  $P = 750 \text{ W}$

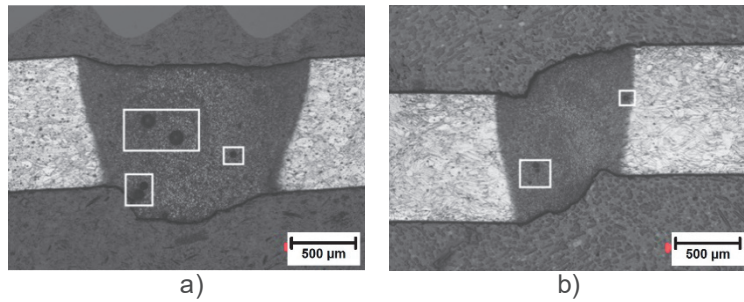
Milling the edges with an angle leads to easier sample set up, as it enabled setting without gap and without misalignment. Yet this edge inclination leads to longer joint edge, longer, wider than laser beam diameter (1 mm), so that lack of fusion would occur, when welding with laser beam at focus. This was done and the penetration test proved lack of penetration at the root of the weld for joints prepared by milling with angle  $45^\circ$ , the edges were incompletely melt. To accommodate for the higher joint width, the welding was done with laser out of focal point, yet even defocused distance did not lead to acceptable joints for angle  $45^\circ$ . The increase of necessary power to  $P = 1000 \text{ W}$  resulted in burn through, sagging, porosity and uneven melting. Such defects are visible in **Fig. 6**. **Fig. 6a** shows porosity and weld sagging.

**Fig. 6** Weld defects present in the butt welds - a) porosity for too high power,  $P = 1100 \text{ W}$ ,  $f = +5 \text{ mm}$ ,  $v = 80 \text{ mm}\cdot\text{s}^{-1}$ , b) Weld misalignment  $P = 650 \text{ W}$ ,  $f = 0 \text{ mm}$ ,  $v = 80 \text{ mm}\cdot\text{s}^{-1}$

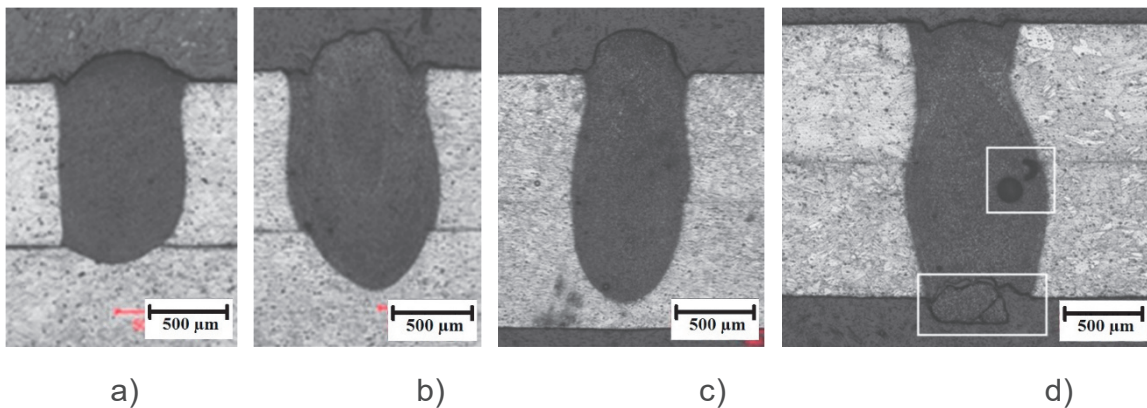
For lap joints the laser power was varied  $P = 550 - 900 \text{ W}$ . Focal spot was on upper weld surface,  $v = 80 \text{ mm}\cdot\text{s}^{-1}$ . The sheets surface was ground from oxides and degreased. In **Fig. 7** there are results for varied laser power. The best results were reached with power  $P = 600, 700 \text{ W}$ .

**Fig. 7** Lap joints, macrographs a)  $P = 600 \text{ W}$ , b)  $P = 650 \text{ W}$ , c)  $P = 700 \text{ W}$ , d)  $P = 800 \text{ W}$

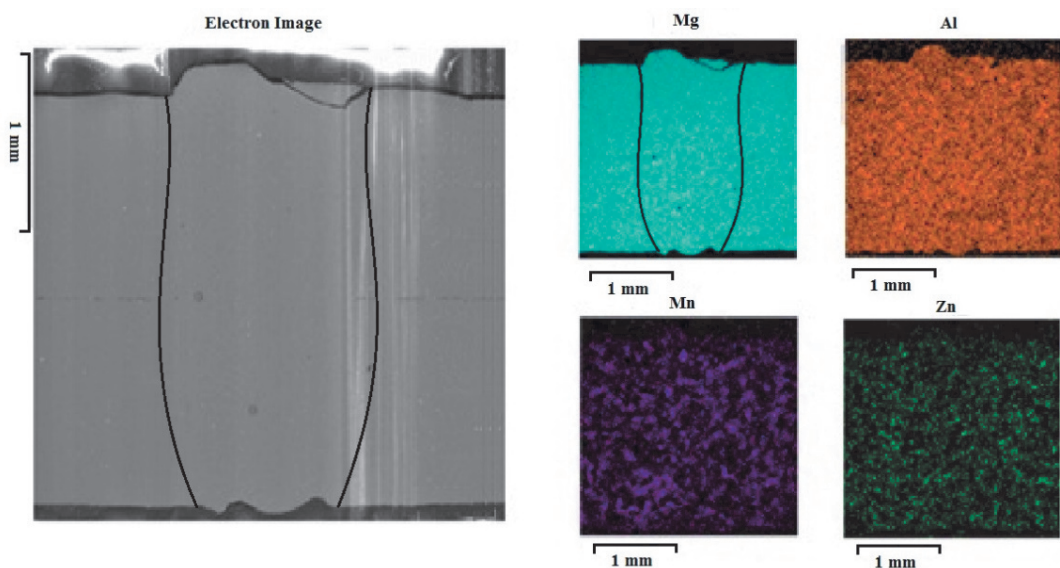
**Fig. 8** Surface EDX analysis - lap weld

EDX analysis served to observe chemical composition change due to laser welding. It is known that high energy beam welding leads to uneven changes in presence of some alloying elements due to their low sublimation temperature [1], e.g. Mg, Zn. In **Fig. 8** results for Mg, Al, Mn, Zn concentration after welding of lap joint are shown. The results did not prove any substantial change in chemical composition before and after welding. The sublimation of Mg, Zn and other elements is not having important influence as found in our research.

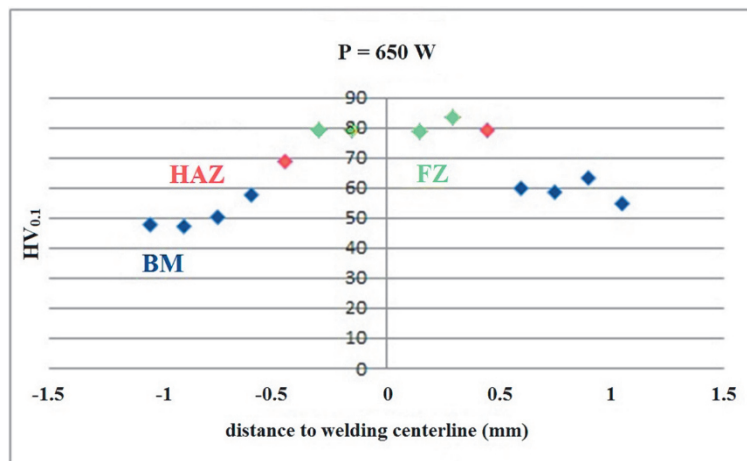
The butt welds hardness was measured across the joint in 1 line, for lap joints 2 lines of measurement were done. In **Fig. 9**, increase of hardness in WM (80 HV<sub>0.1</sub>) and HAZ (75 HV<sub>0.1</sub>) compared to BM hardness (55 HV) is visible. Similar results were reached for lap joints. Hardness increase is connected with grain refinement caused by fast solidification process.

**Fig. 9** Microhardness across the butt joint,  $P = 650 \text{ W}$ ,  $v = 80 \text{ mm}\cdot\text{s}^{-1}$
